# Manhole Inspection Summary

Manhole # S33YY1015MH

Insp Date: **1/25/07 8:01 AM**

**Location** Address: **5219 SPRINGLAKE WAY**

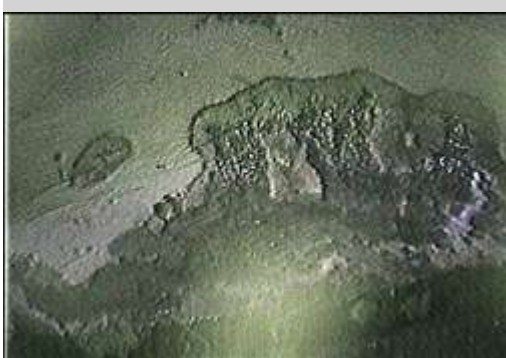
Defect 2

Infiltration: ☐ None ☐ Joint ☐ Cracks ☐ Mortar ☐ Roots ☒ **Wall**

Barrel infiltration.

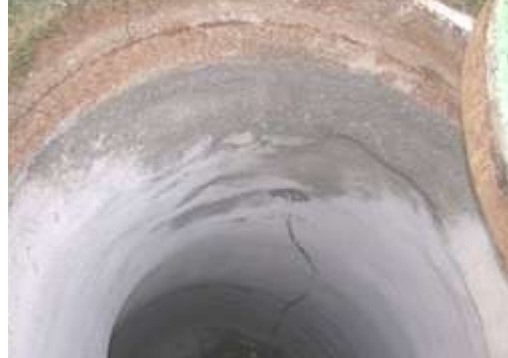
Defect

Infiltration: ☐ None ☒ **Joint** ☐ Cracks ☐ Mortar ☐ Roots ☐ Wall

Adjustment, Corbel, and Barrel infiltration.

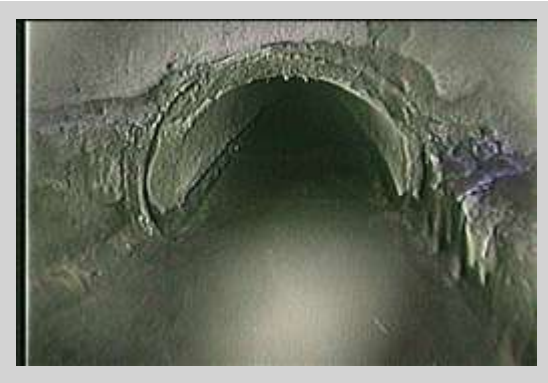
### 12 in. Circular Gravity Sewer Pipe Out @ 12 O'Clock

Infiltration: **Evidence** Pipe Seal Cond: **Cracked**

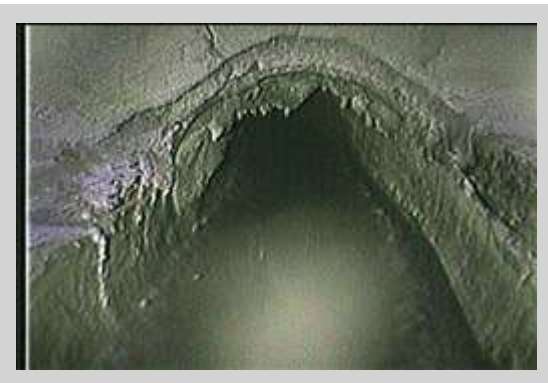
### 12 in. Circular Gravity Sewer Pipe In @ 6 O'Clock

Infiltration: **Evidence** Pipe Seal Cond: **Unknown**

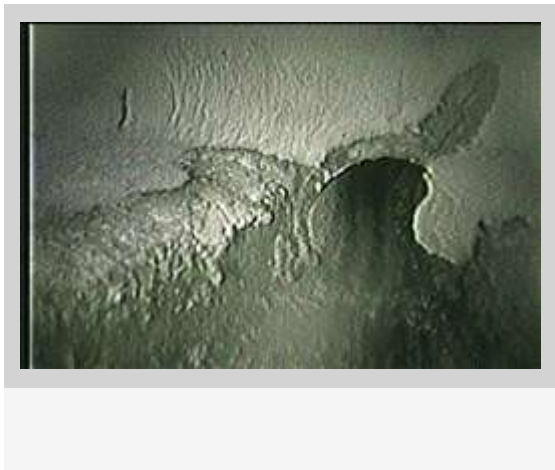
6 in. Circular Gravity Sewer  
Pipe In @ 9 O'Clock

Infiltration: **Evidence** Pipe Seal Cond: **Unknown**
